# QUICK TRAFFIC RECOVERY AFTER THE NIIGATAKEN CHUETSU-OKI EARTHQUAKE IN 2007

**Yoneo OKA, Yu SHIBUYA, Kazuhiro ONOZUKA**  
*East Nippon Expressway Company Limited, Niigata Bureau*

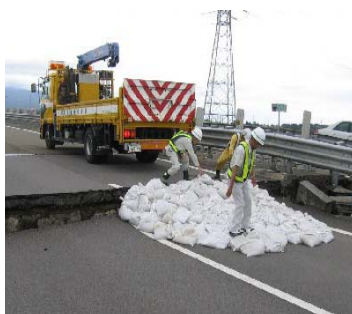
Photo 1. Repair of difference in level on road surface

In order to secure a road surface on which emergency vehicles could drive slowly, emergency inspection was conducted, and stored sandbags were placed at the difference in level on the road surface. As a result, traffic routes were secured for emergency vehicles within a short period of time (approximately 4 hours after the earthquake), which greatly contributed to restoration work in the affected area (Photos 1 to 3).

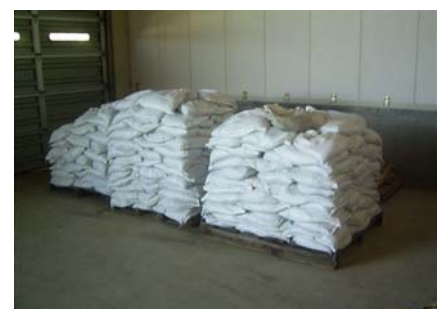
Photo 3. Stored sandbags

The sandbags had been stored at the Nagaoka IC and the Kashiwazaki IC since the Mid Niigata Prefecture Earthquake in 2004, which was a magnitude 6.8 earthquake (seismic intensity of 7 in Kawaguchi-machi, Niigata) that occurred 4 years ago on October 23, 2004.
